District of Columbia Water and Sewer Authority

Soapstone Valley Creek Bed Sewer Rehabilitation Project

Sewer Assessment
March 15, 2011

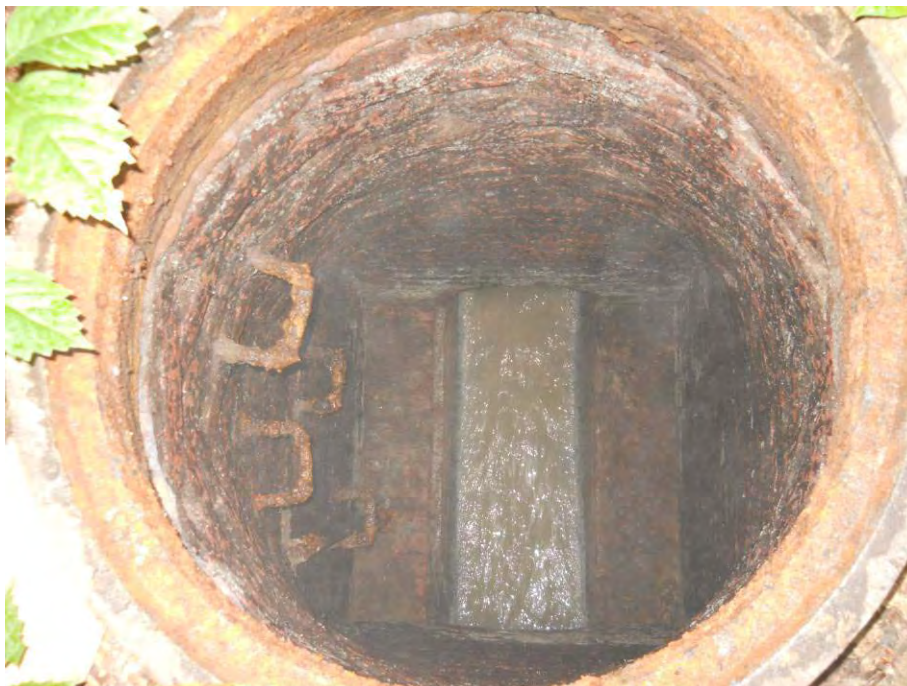
Manholes for the Soapstone Valley sewer system were constructed using brick and mortar. Corrosion inside the manholes was observed throughout the system. Manhole covers were mostly rusted closed and some of them were welded shut. Manhole frames were rusted along with the steps.

Photo – View of Sanitary Manhole M-9763 with corroded frame and steps

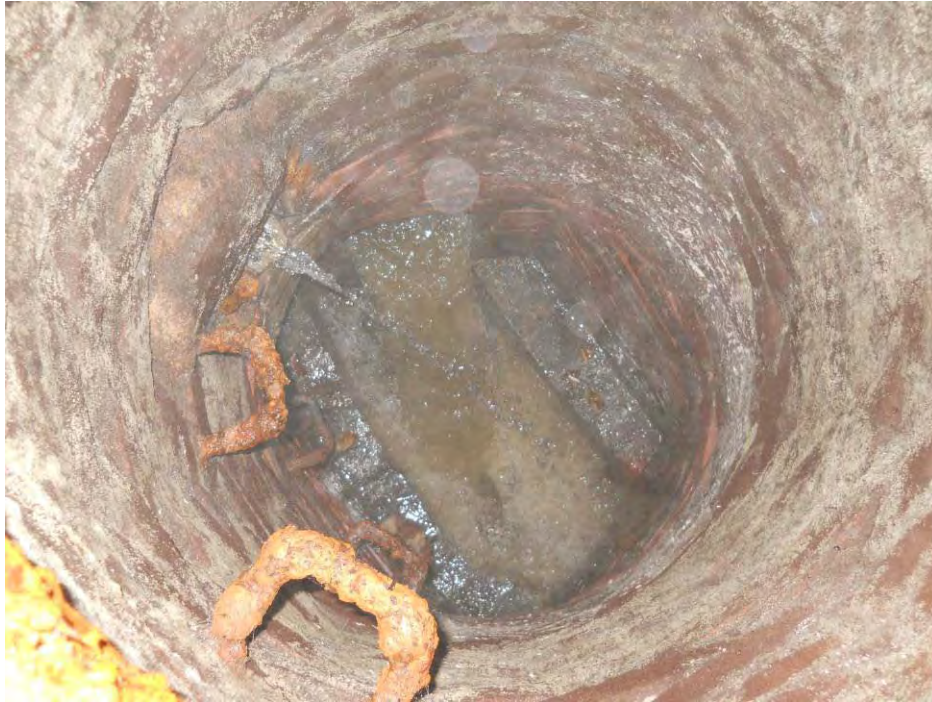
Photo – View of Sanitary Manhole M-10363 with 6-inch connection

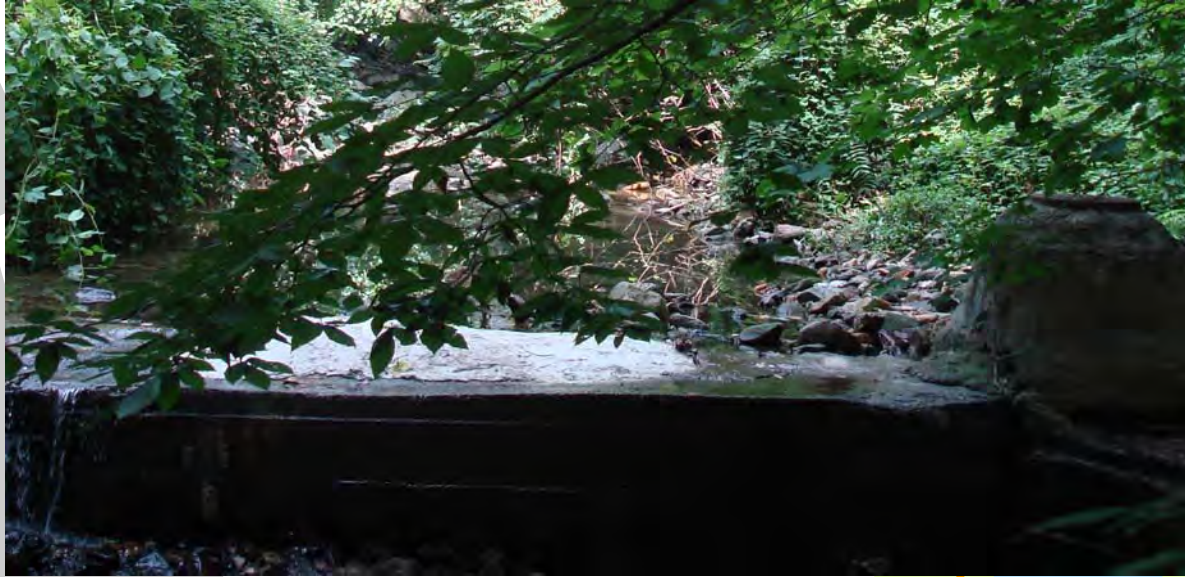
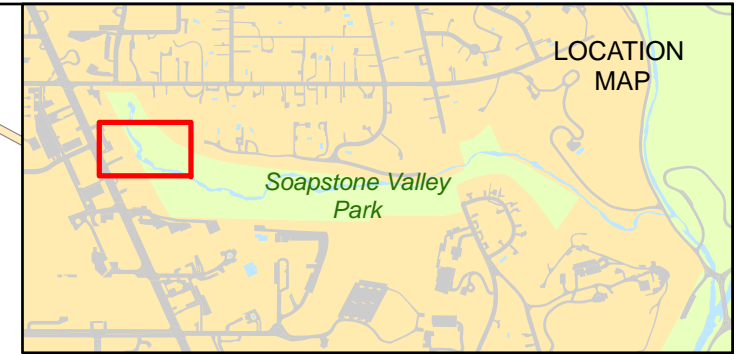
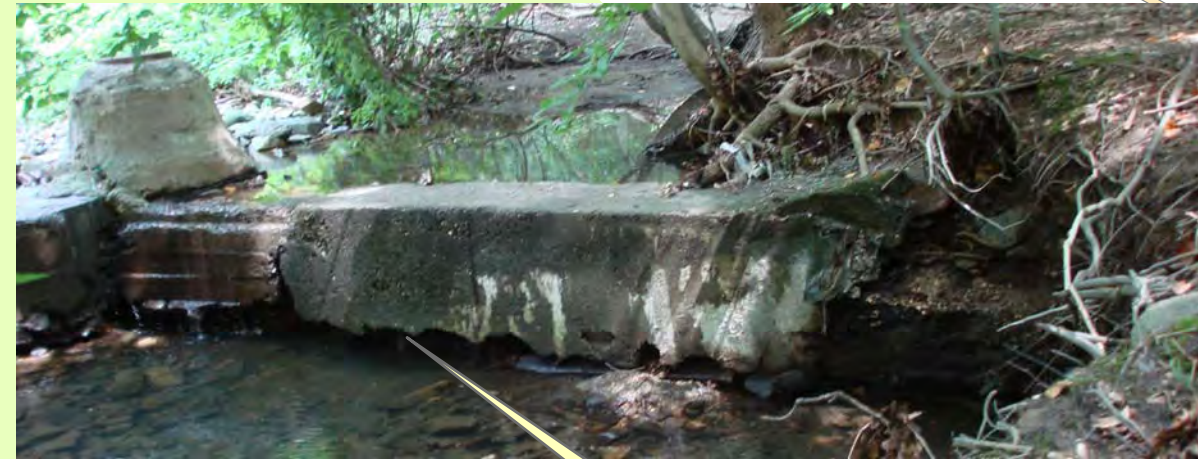
Undermining of the sewer crossing with visible flow of stream from below the sewer

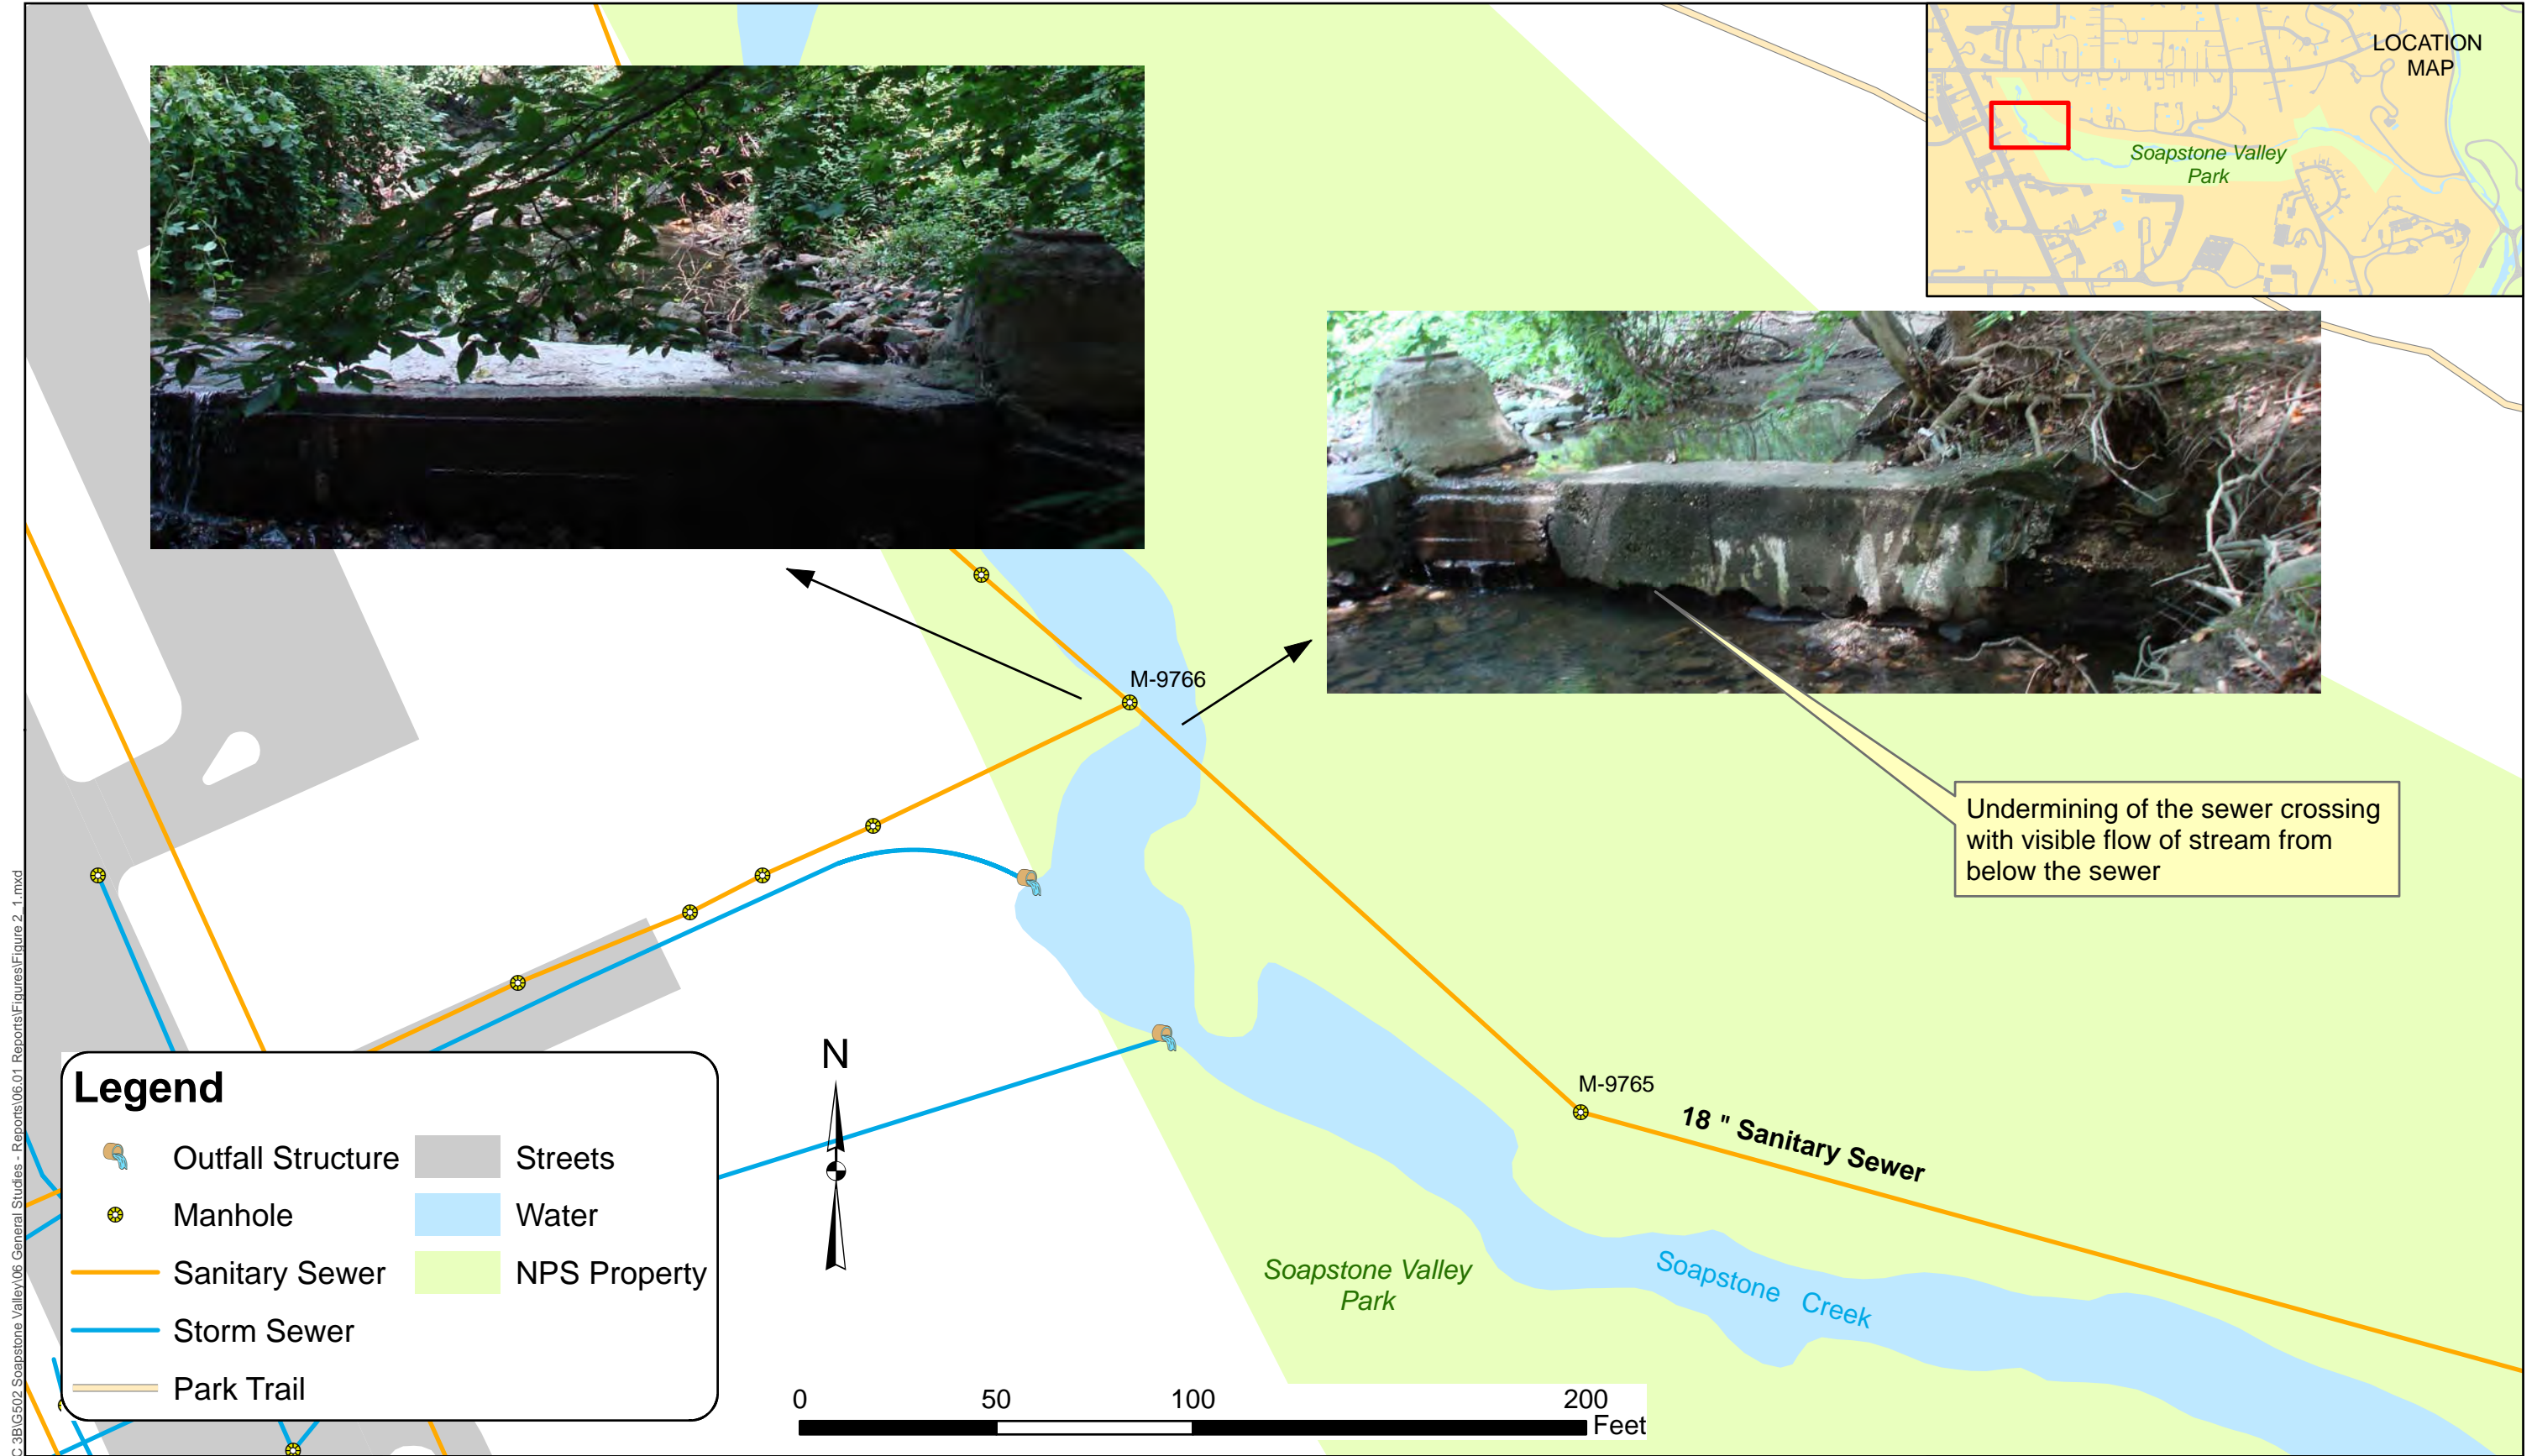
Figure 2.2

Sewer Crossing at Manhole M-9766

- Replace or relocate the sewer crossings indicated on Figure 3.1 with structural encasement for pipe integrity
- Rehabilitate approximately 4000 ft of the buried 18” sanitary sewers inside Soapstone Valley National Park with UV CIPP or similar trenchless method
- Stabilize the stream banks at the stream crossings to avoid any further erosion of the banks at the crossings

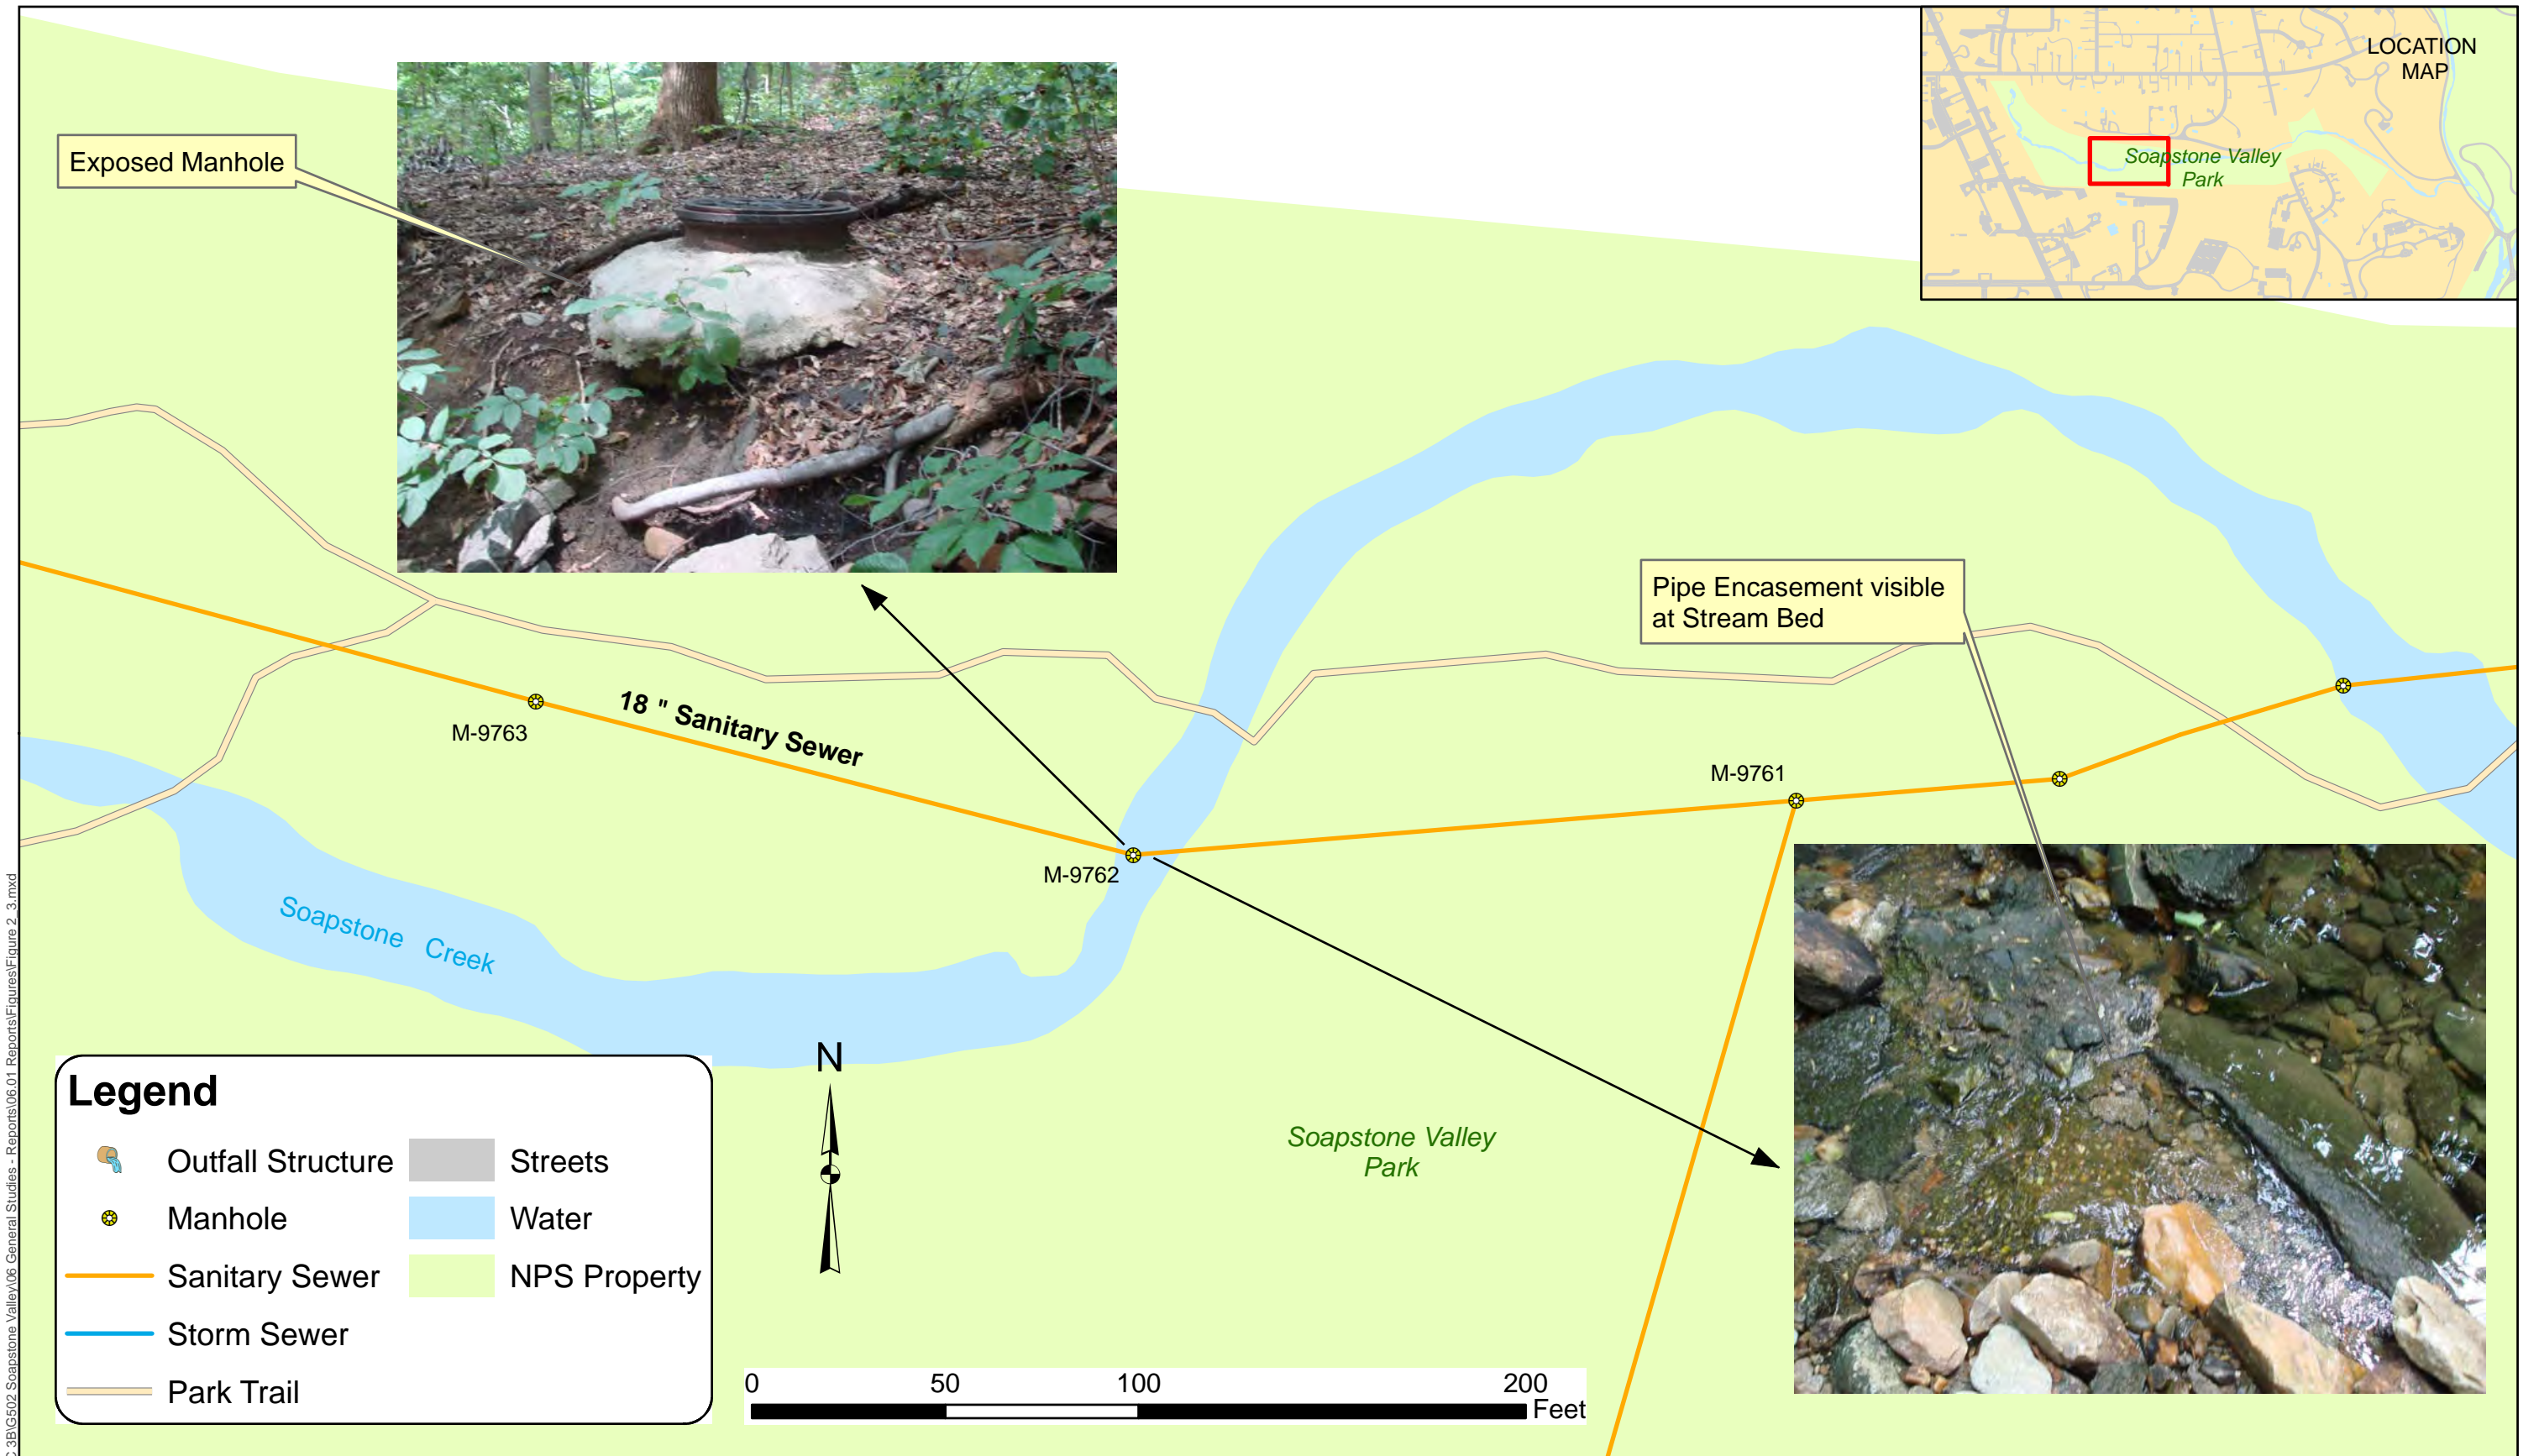
Figure 2.3

Sewer Crossing at Manhole M-9762

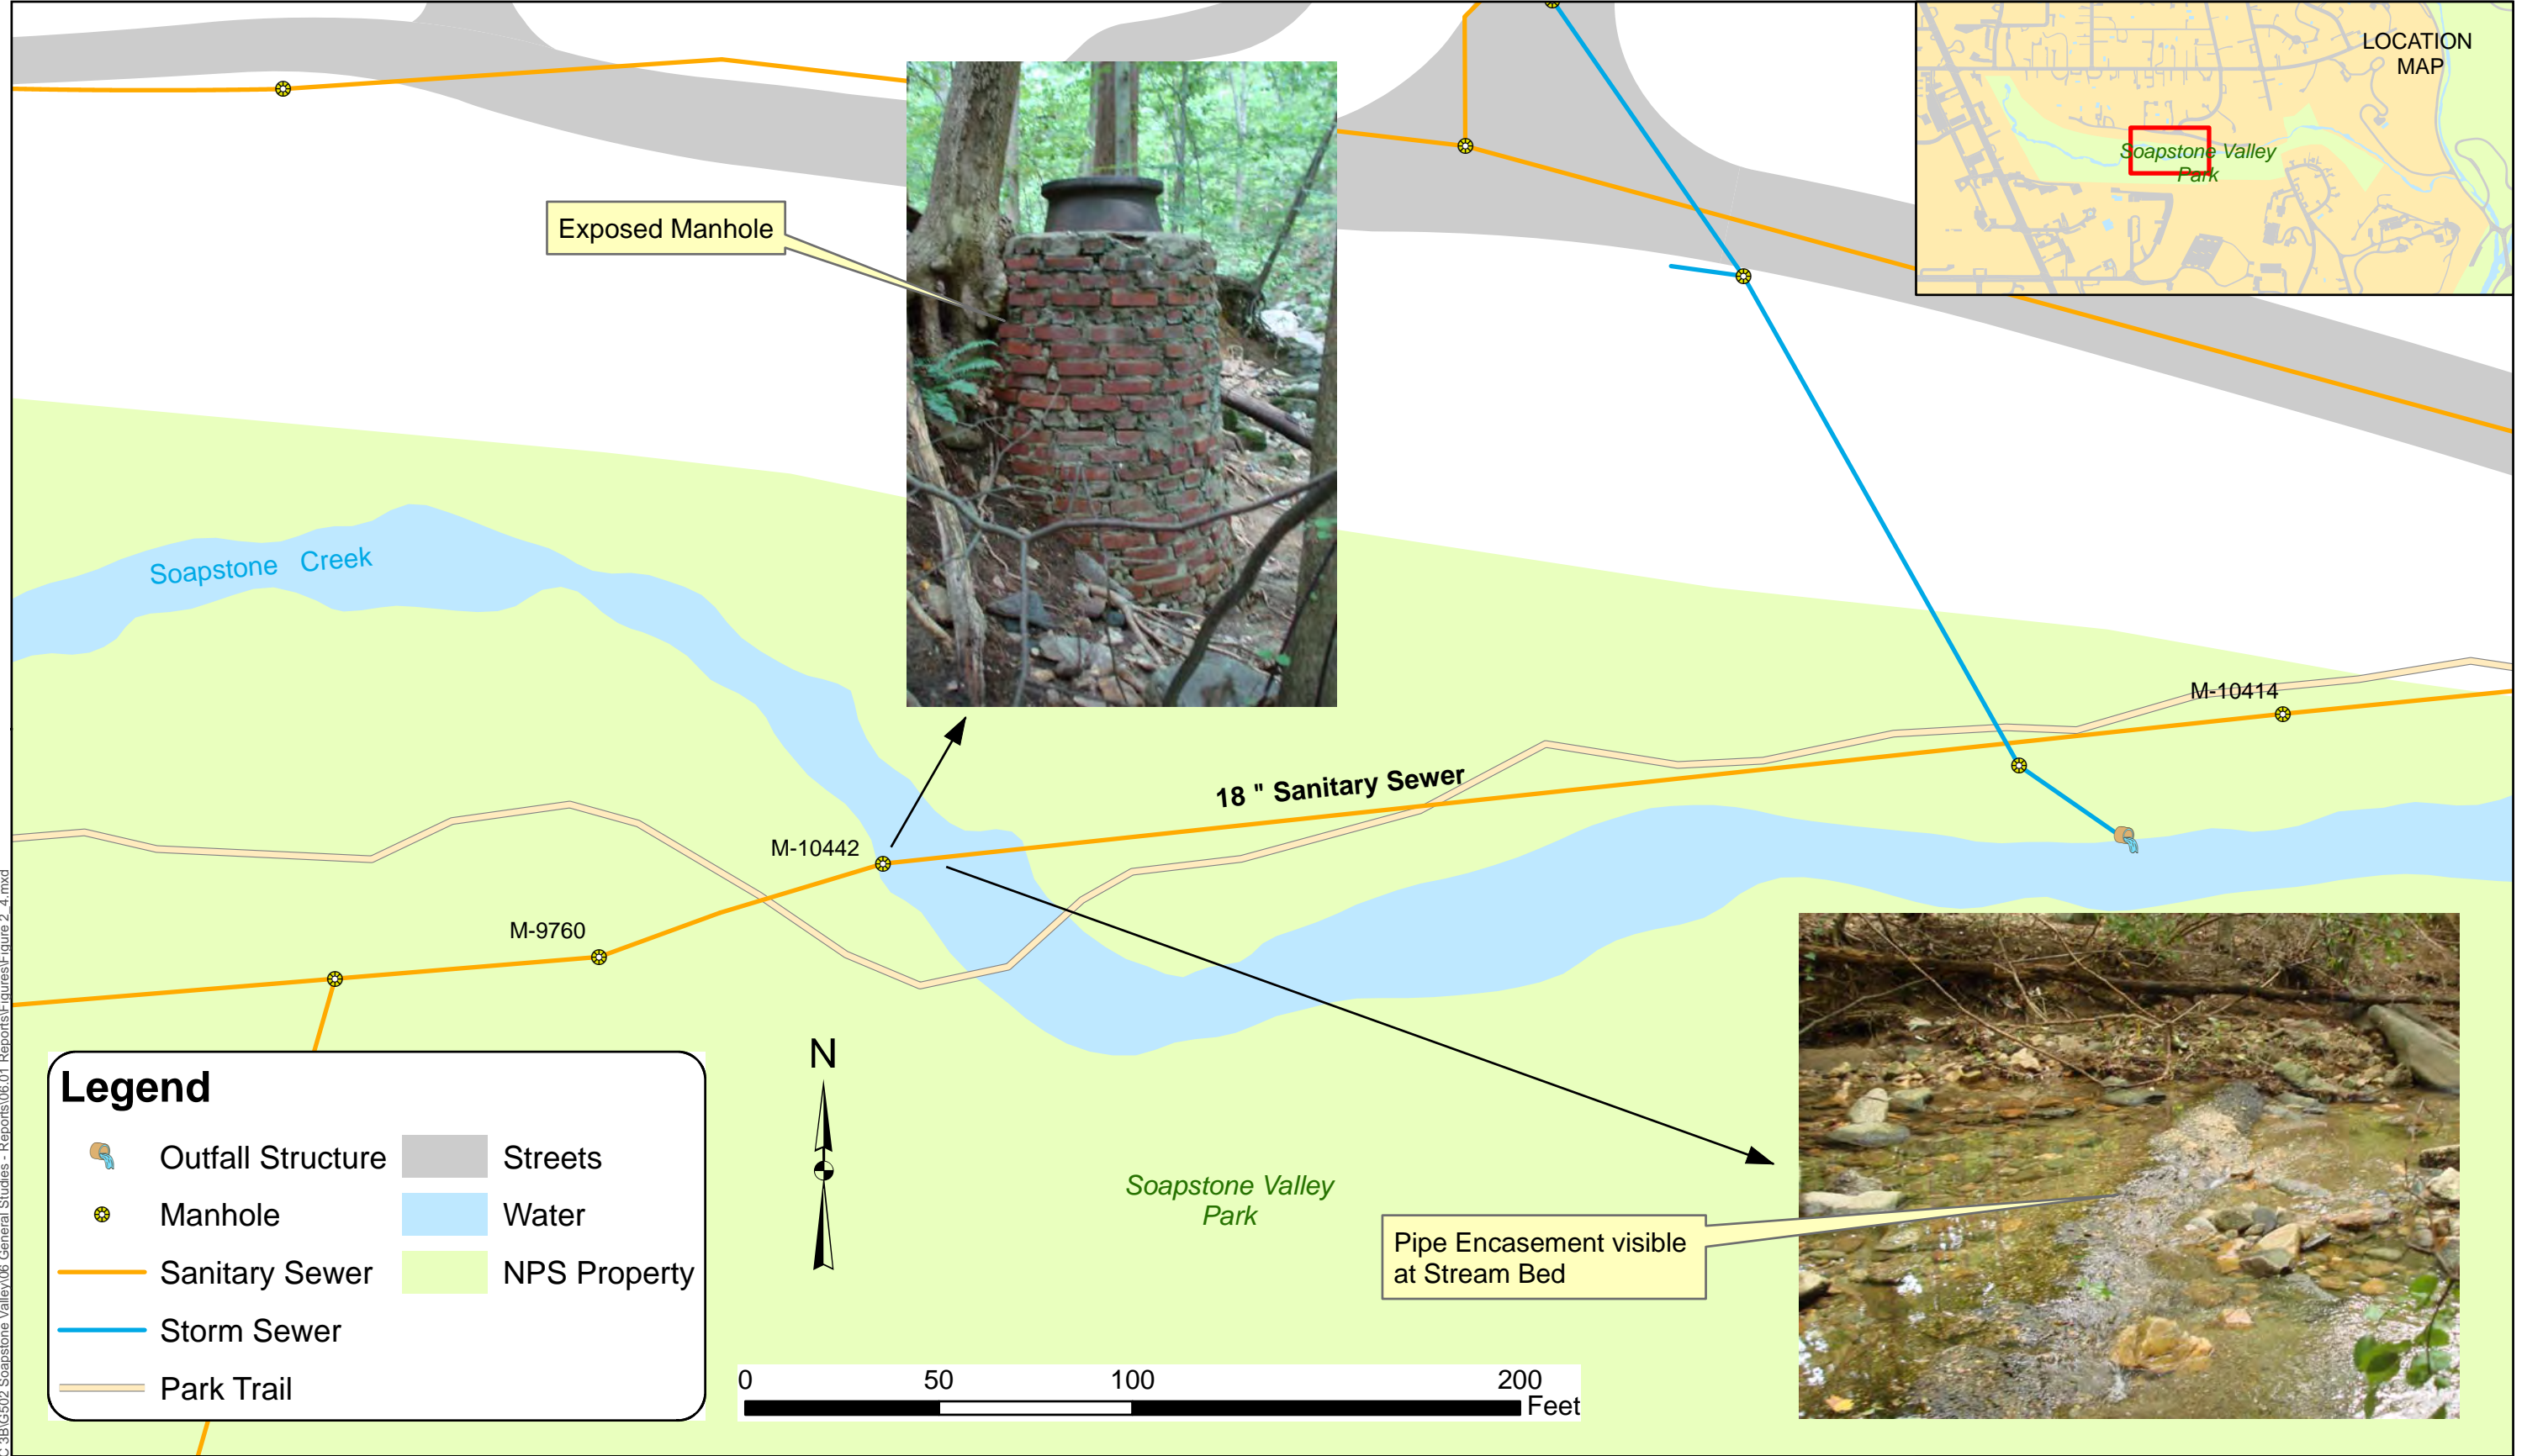
Figure 2.4

Sewer Crossing at Manhole M-10442

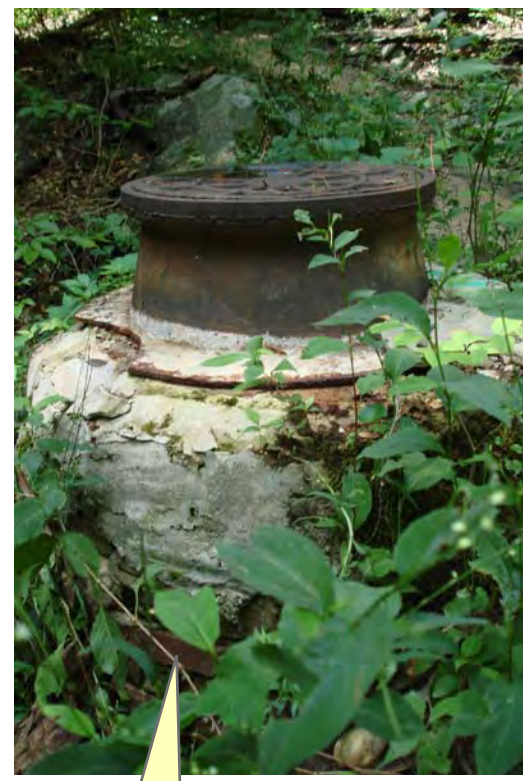
Exposed Manhole

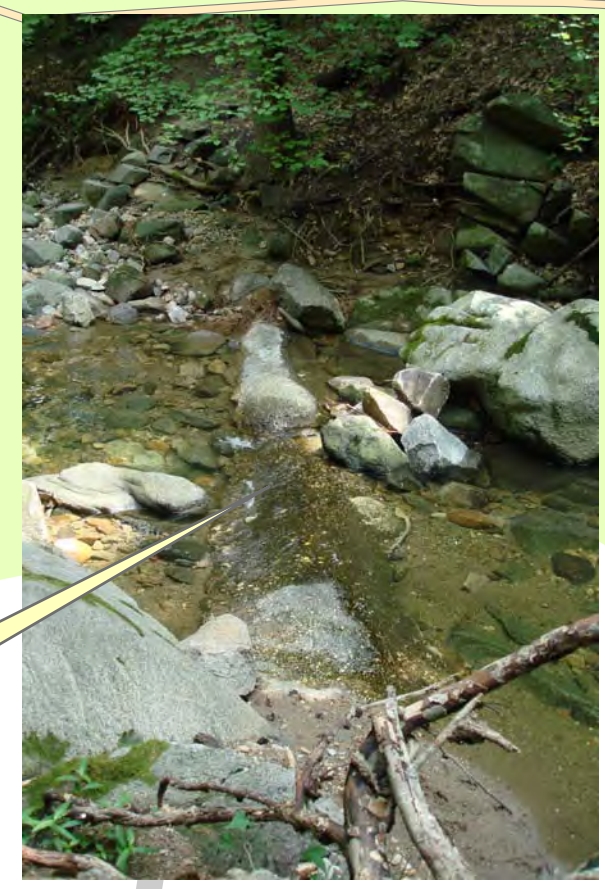
Pipe Encasement visible at Stream Bed

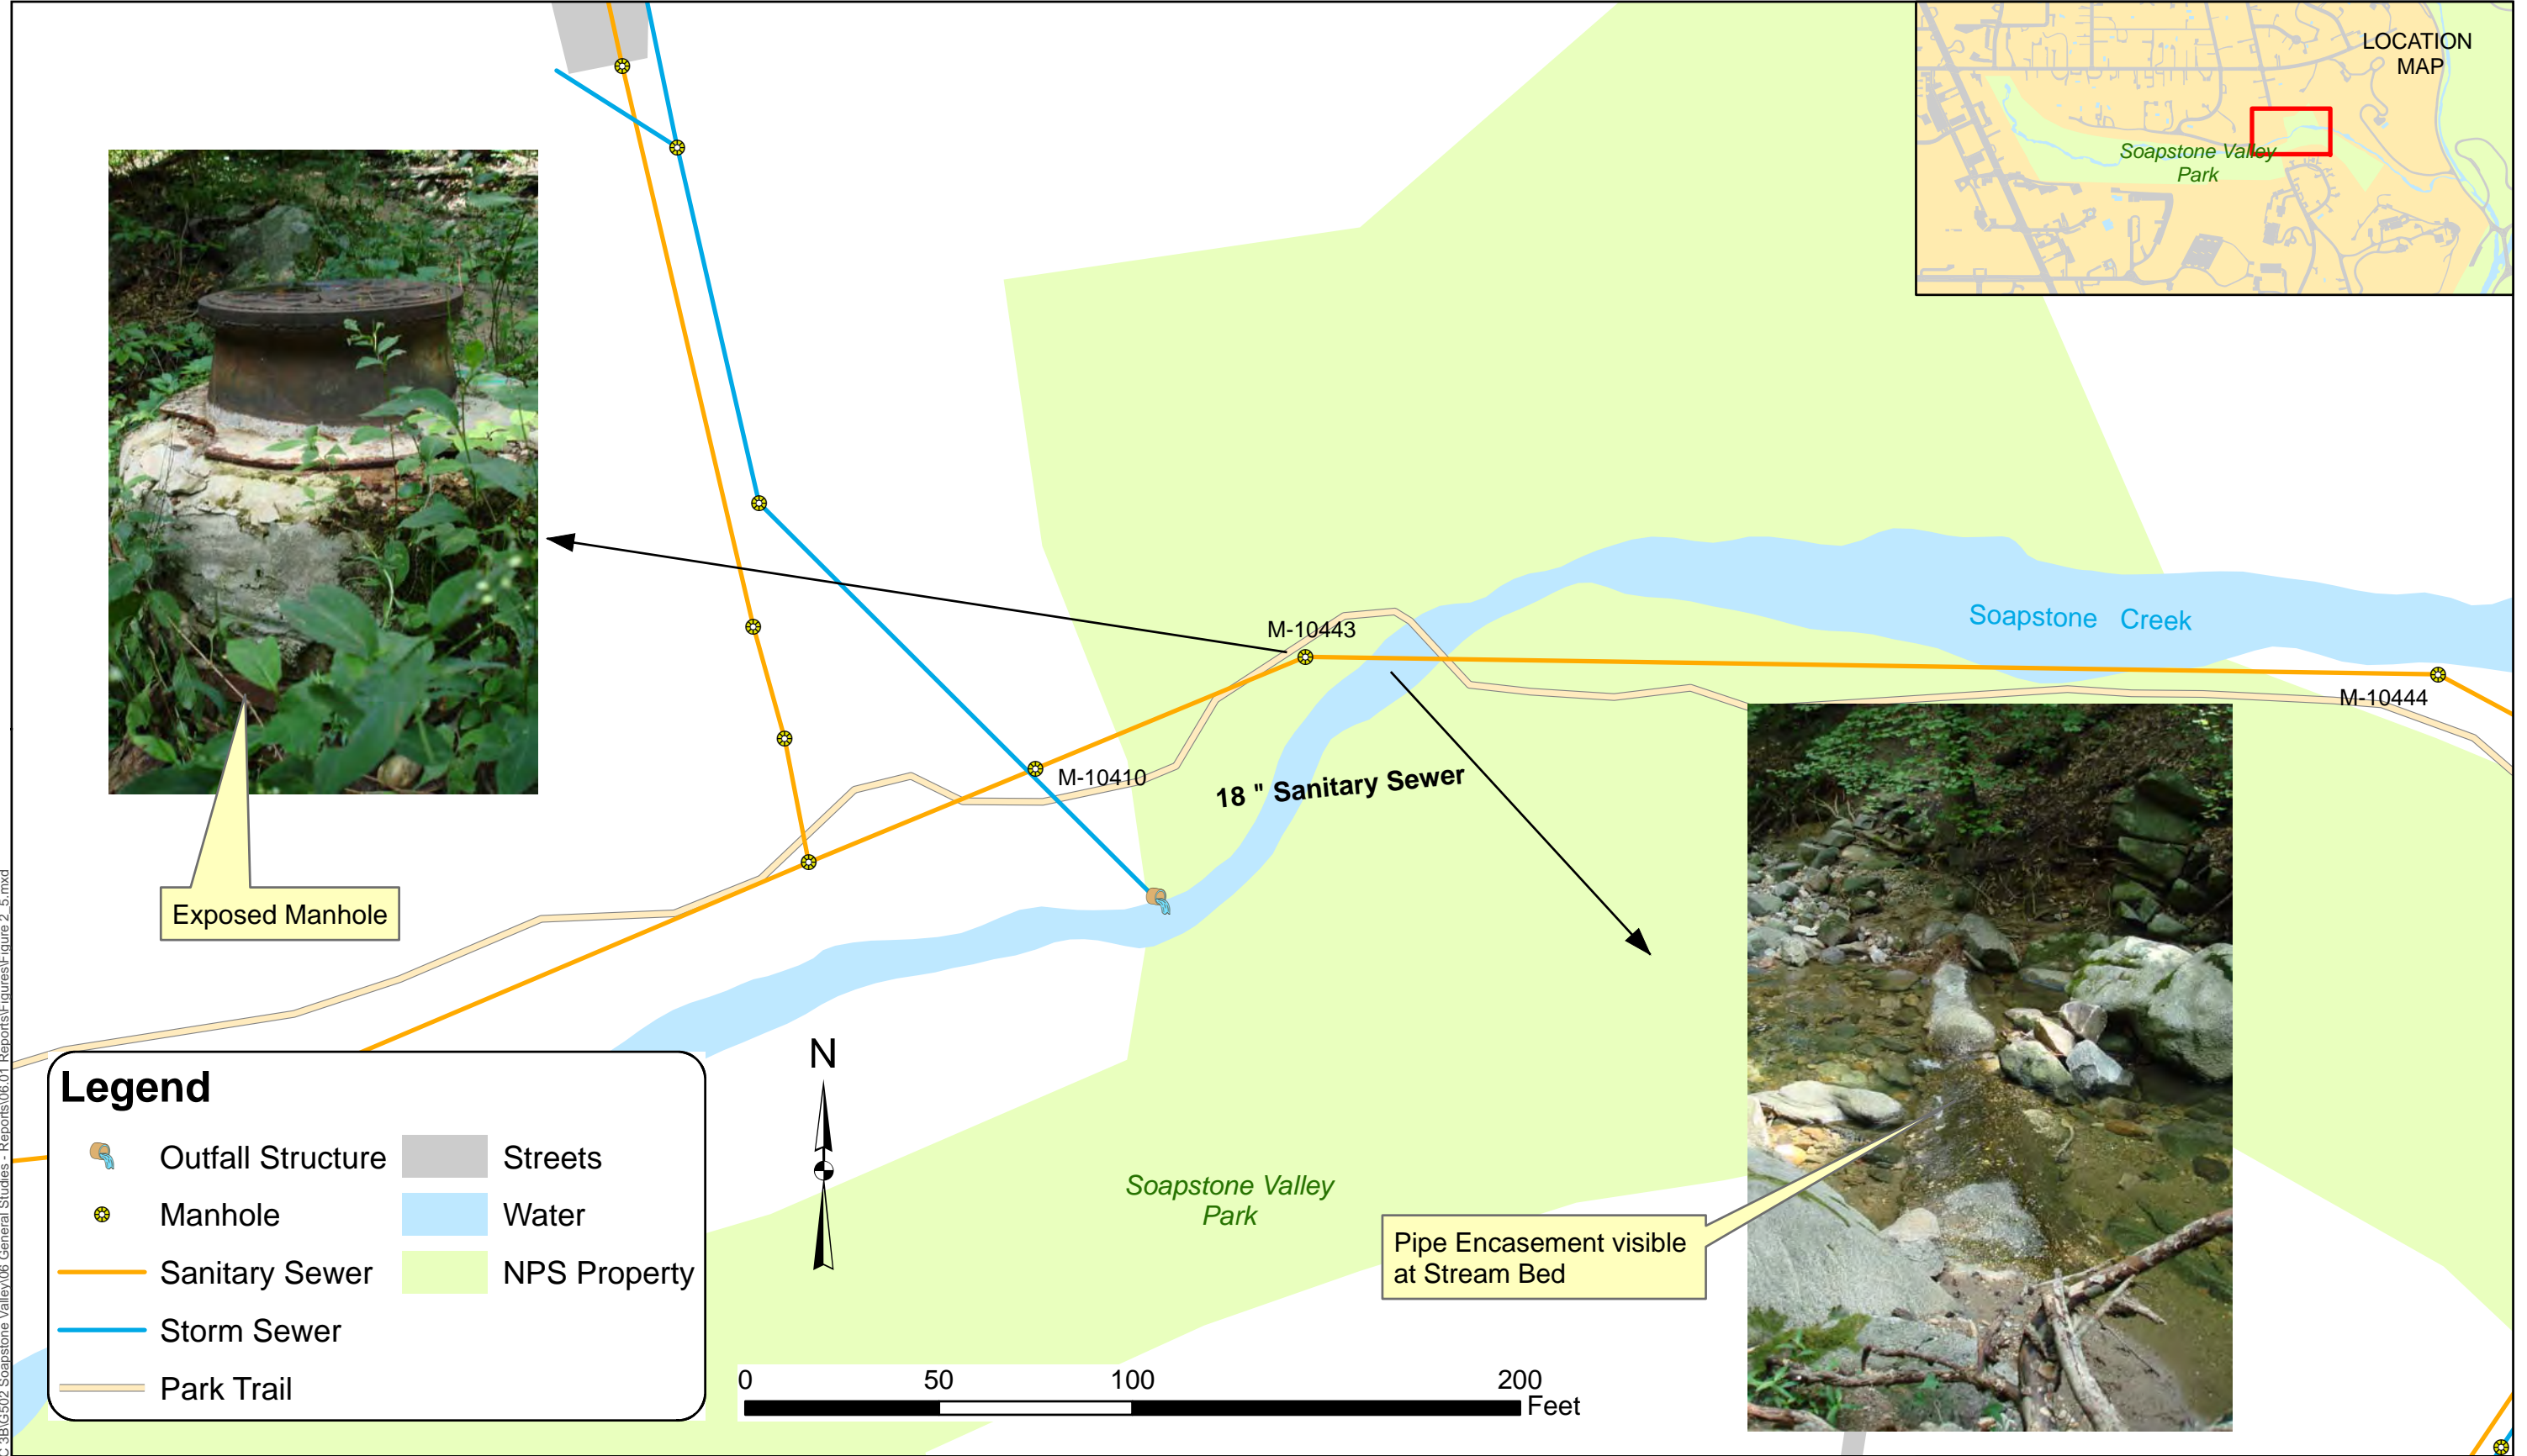
Sewer Crossing at Manhole M-10443

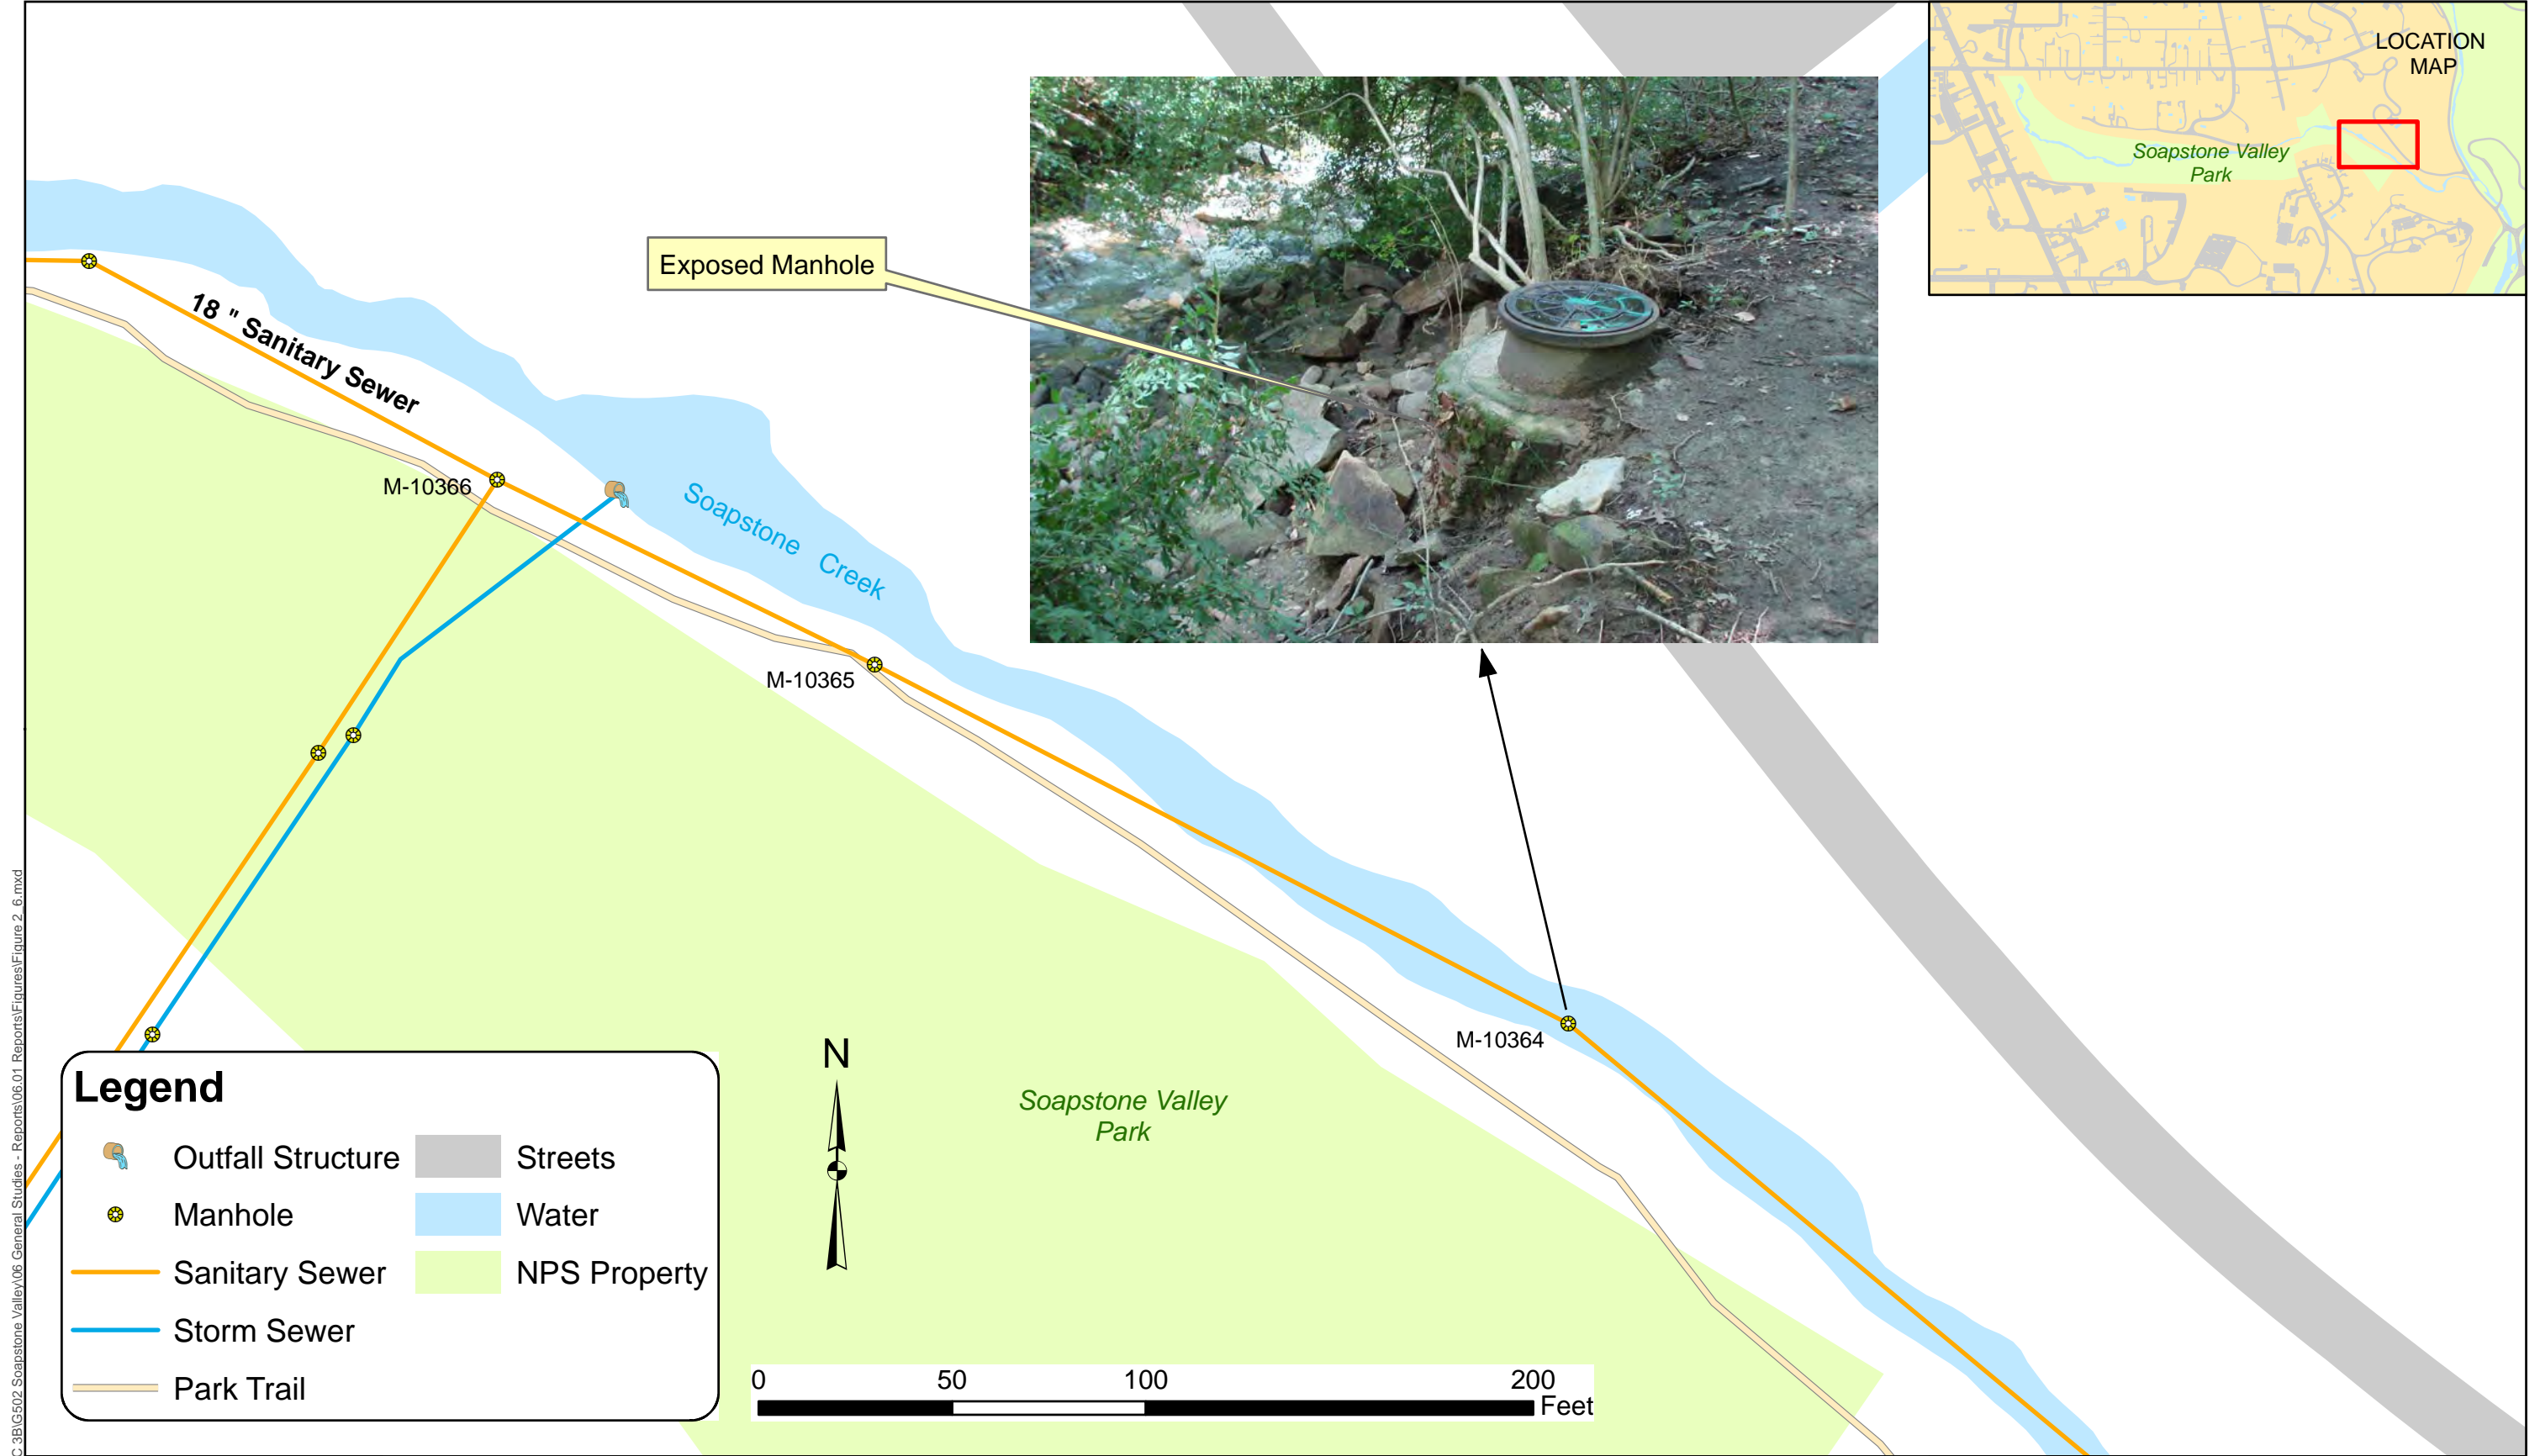
Figure 2.6

Exposed Manhole M-10364
