District of Columbia Water and Sewer Authority

Soapstone Valley Creek Bed Sewer Rehabilitation Project

Sewer Assessment
March 15, 2011

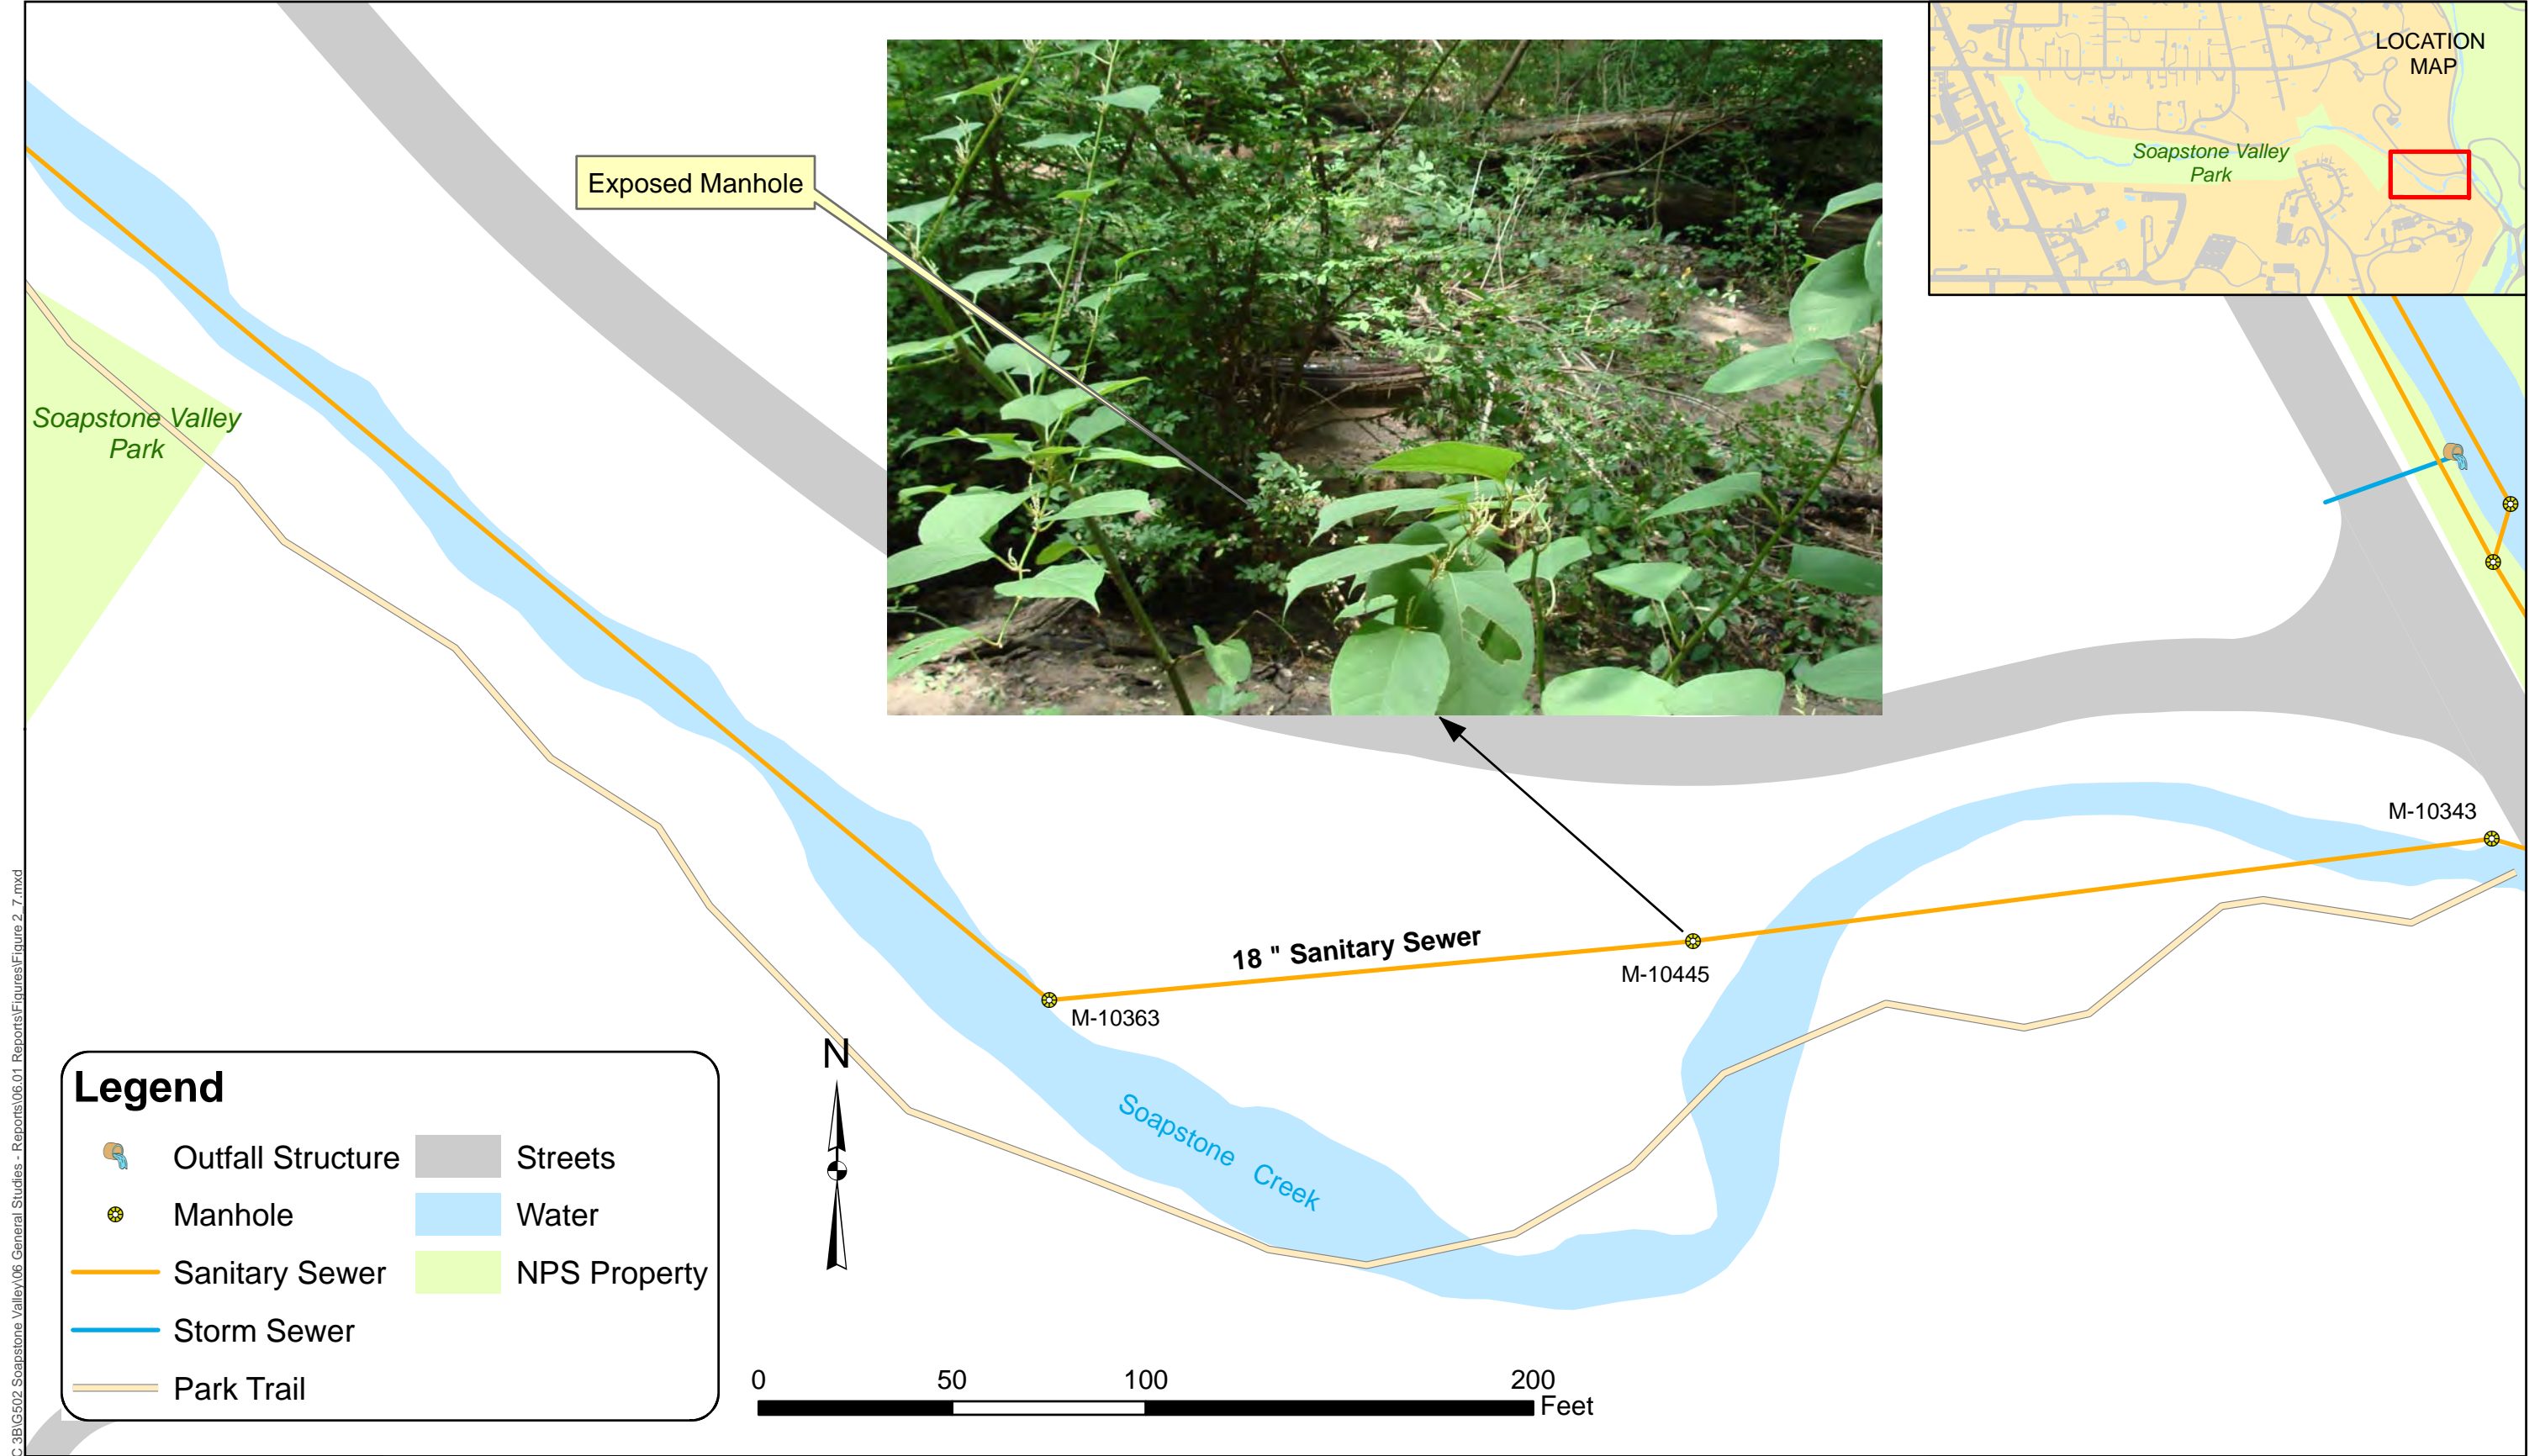
Exposed Manhole M-10445

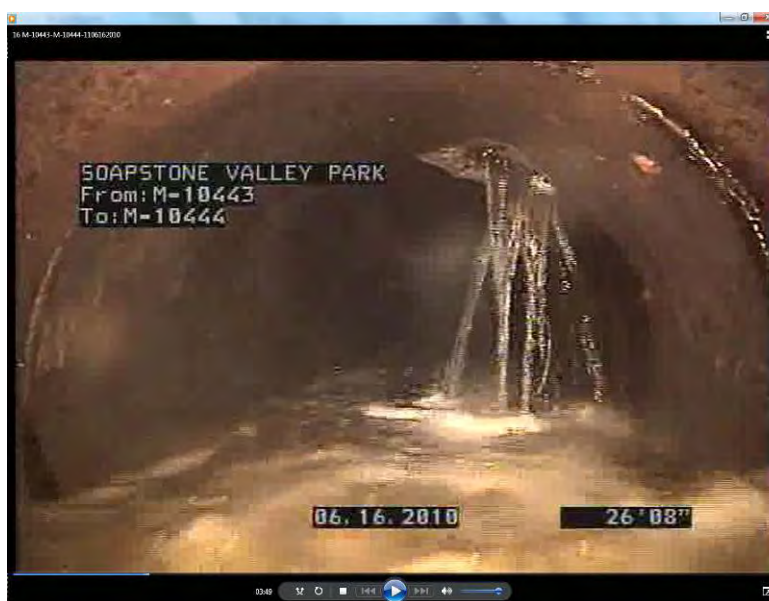
Active infiltration was observed in the sanitary sewers during the CCTV inspection predominantly where the sewer pipe crossed the stream. The sewer stream crossing between manholes M-10443 and M-10444 was observed to have high active infiltration as shown in the picture below. The location of the leak was later found and immediately referred to DC Water's DSS for repair. DSS immediately fixed the hole in the pipe, where a rock had fallen against the clay pipe causing a leak, with exterior cementitious grout and stopped the infiltration at this location.

Photo – Example of Active Infiltration

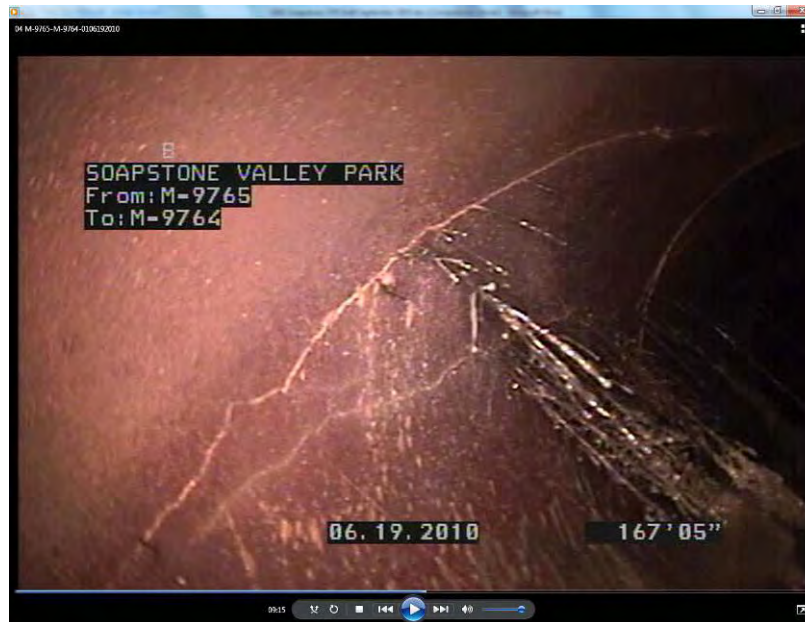
Cracks in the sewer pipe, both longitudinal and multiple, were observed throughout the sanitary line during the internal inspections. In general, VCP has a tendency to fail, especially those pipes installation with shallow cover over the pipe. External point loads exceeding the pipe hoop strength tend to deform the pipe, creating cracks in it. Failure is often exacerbated by the loss of surrounding soil leading to void formation and loss of soil support to the pipe.

Photo – Example of crown of pipe with multiple cracks (Rotated View)

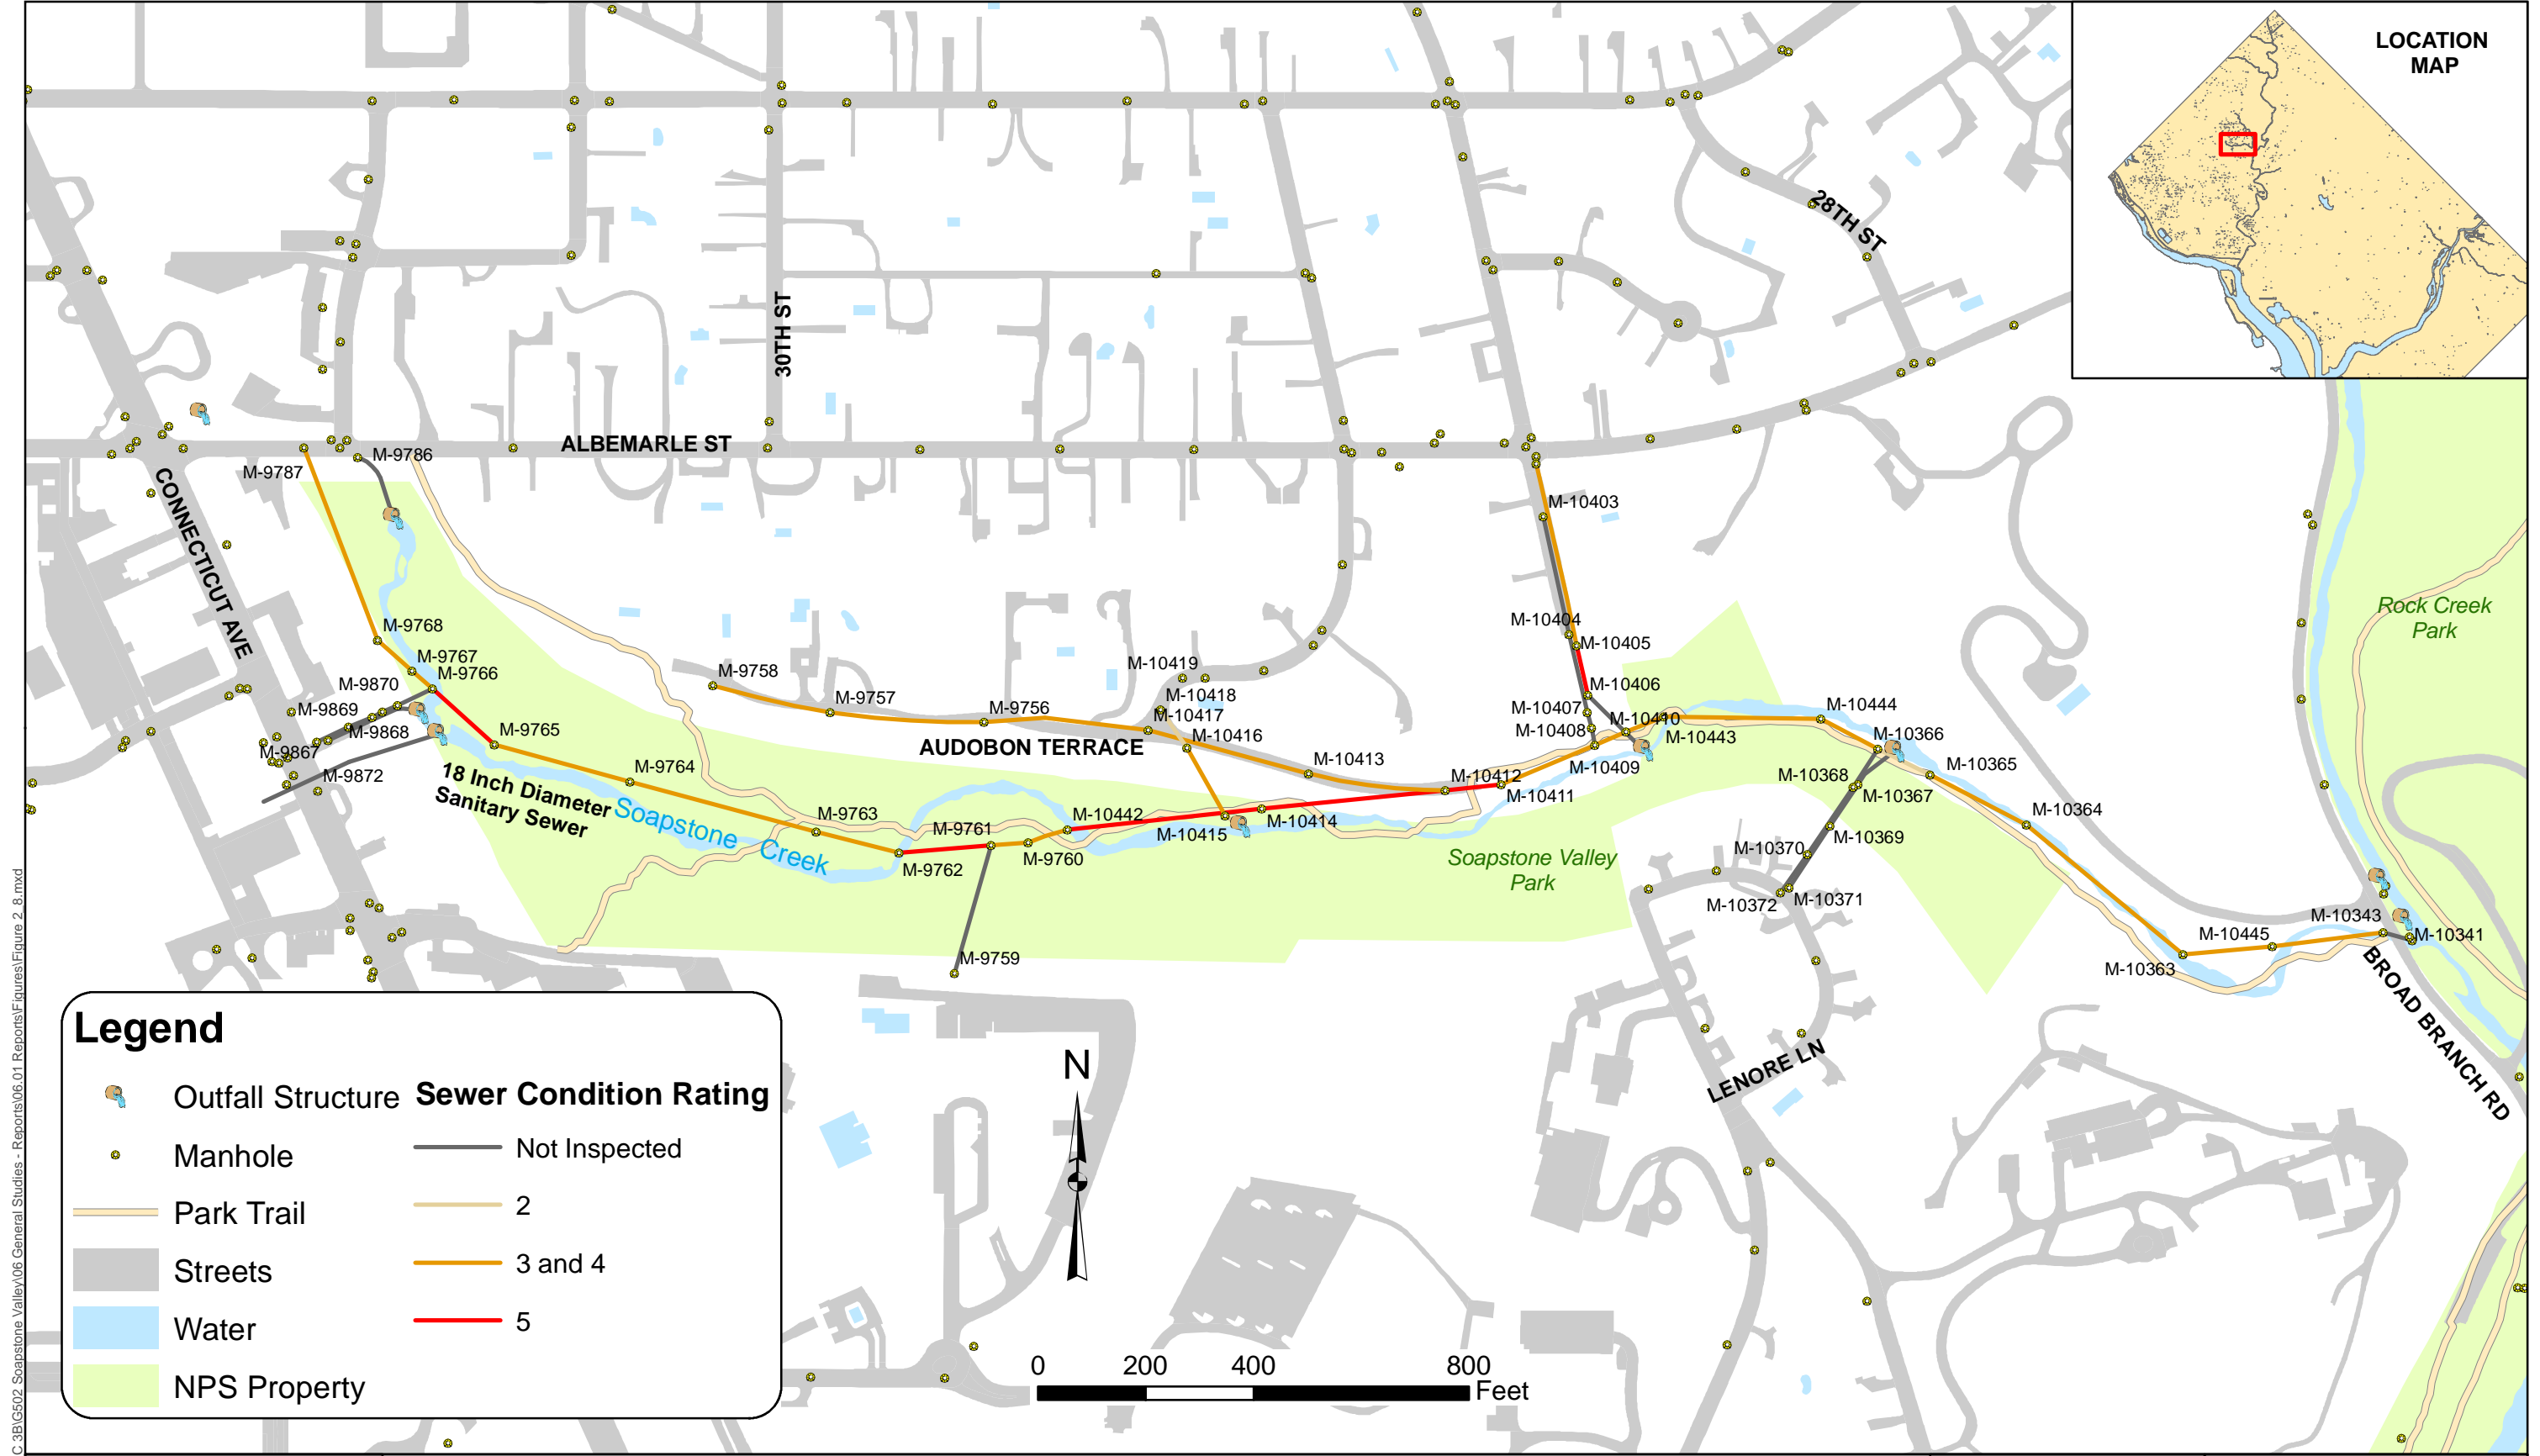
The Structural Segment Rating (normalized defect rating) and Overall Sewer Rating Scores for each sewer segment are included below in Table 2-4. The Sewer Ratings are depicted in Figure 2-8.

Upstream Manhole ID	Downstream Manhole ID	Structural Sewer Rating	Overall Sewer Rating
M-9764	M-9763	2	3
M-9763	M-9762	5	4
M-9765	M-9764	2	3
M-9766	M-9765	6	5
M-9768	M-9766	3	3
M-9787	M-9768	3	3
M-9758	M-9757	4	4
M-9757	M-9756	3	3
M-10417	M-10413	2	3
M-10395	M-10405	2	3
M-10405	M-10406	5	5
M-10413	M-10412	3	3
M-9756	M-10417	4	3
M-10412	M-10411	6	5
